# The Fate Of The U-869 Reexamined, Part III

## The Loss of the German Submarine

By John Chatterton, Richie Kohler, and John Yurga

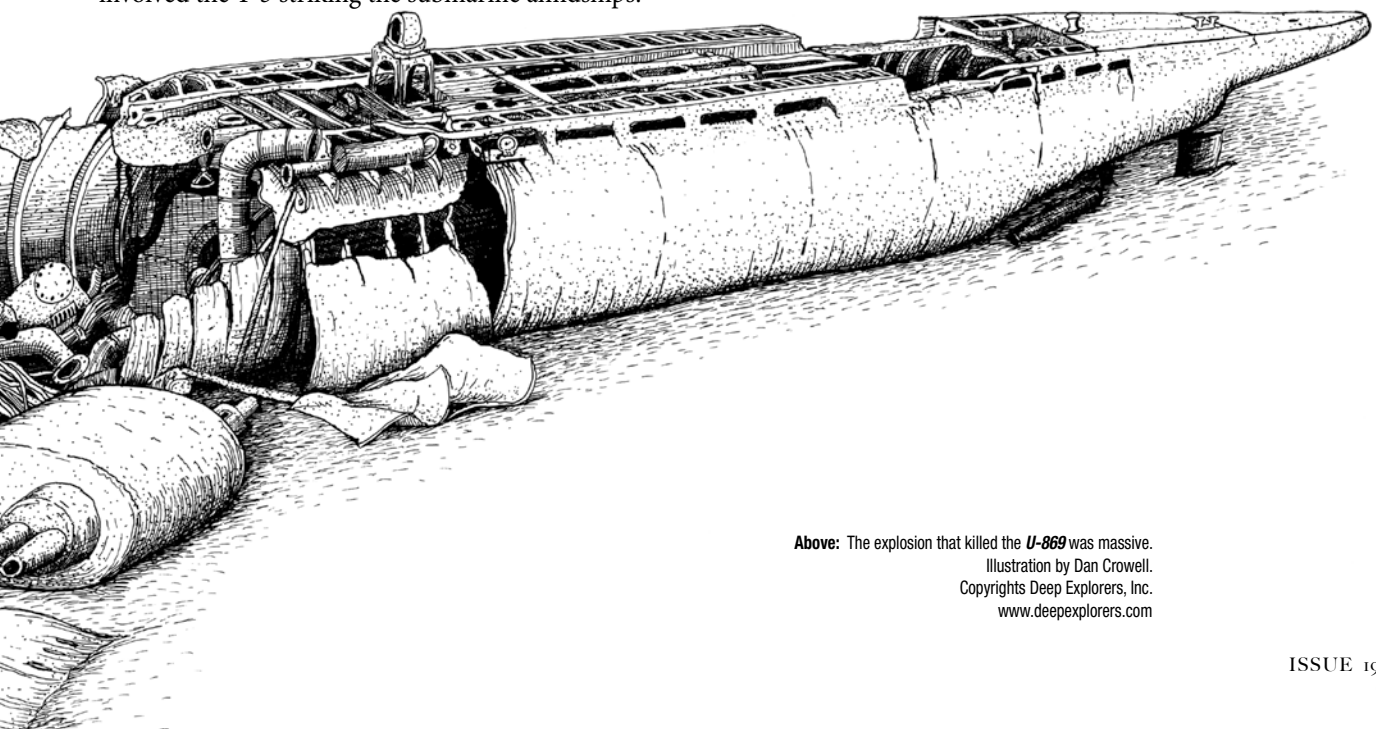
Above: The explosion that killed the *U-869* was massive. Illustration by Dan Crowell. Copyrights Deep Explorers, Inc. [www.deepexplorers.com](http://www.deepexplorers.com)

In a matter of milliseconds, the weapon did exactly what it was designed to do. The shape of the charge helped it cut into the pressure hull of the submarine, leading the explosive train inside the hull. This was aided by the placement of the fusing, which was at the aft end of the explosive warhead, as opposed to the front. This caused the explosive to burn towards the target, supplying even greater penetrating power. **Although the detonation of the torpedo began outside the pressure hull, it continued on into the middle of the Control Room.**

The torpedo triggered a huge concussive wave that blew all of the exterior hatches, and killed the crew instantly. This created the damage in the Control Room that appears to be from an internal explosion, because it actually was. A large amount of oil and floating debris escaped from the ruptured pressure hull, but dispersed in the Atlantic unnoticed at the time.

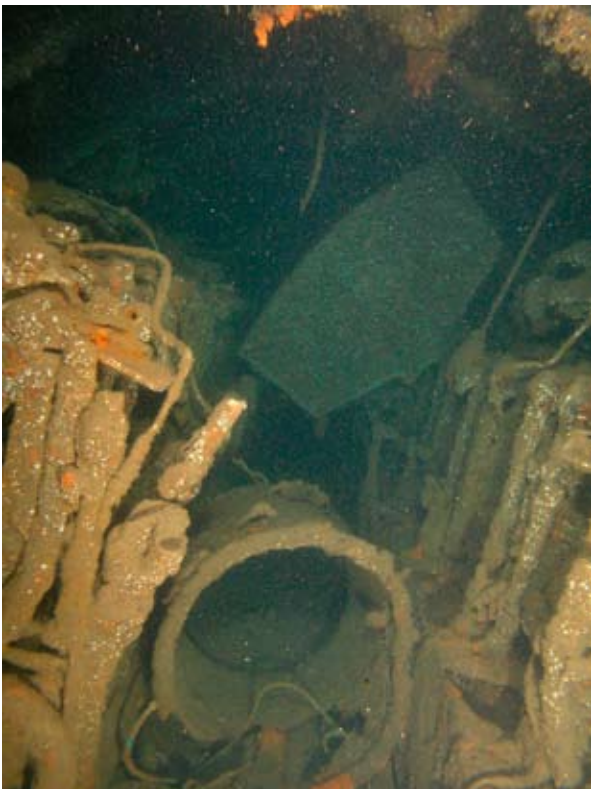
**Above:** View along the upper starboard torpedo tube, looking forward.

**Below:** The view facing aft in the Diesel motor room; the two man diesels with the daily fuel tank that was once suspended on the ceiling now wedged between the motors. The escape trunk lies between the engines on the deck.

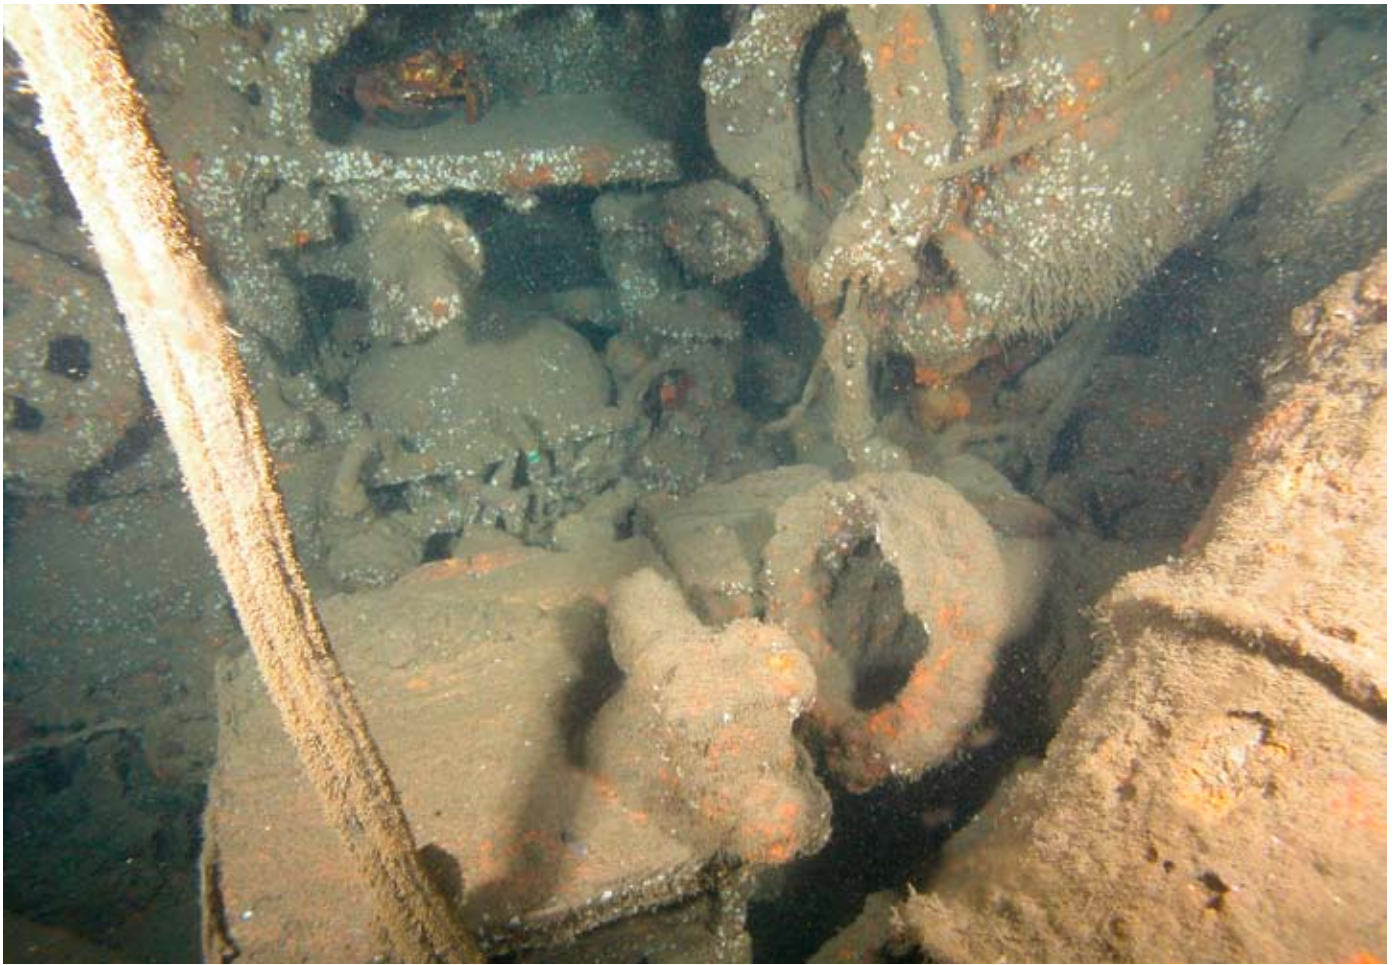
Above: 034 A work bench with vise on the port side of the diesel motor room.

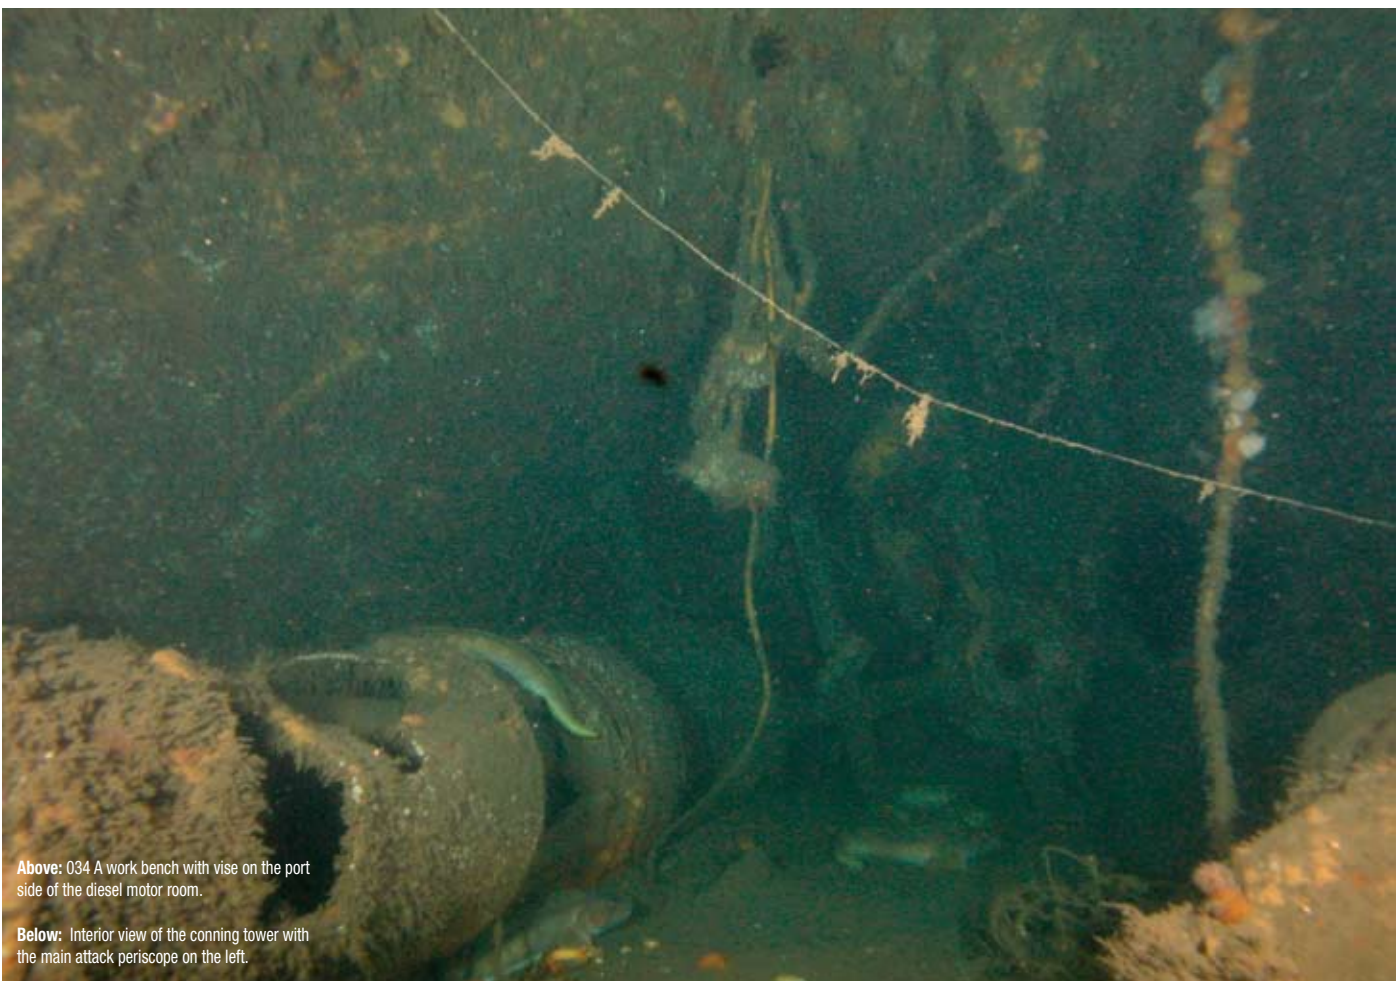
Below: Interior view of the conning tower with the main attack periscope on the left.

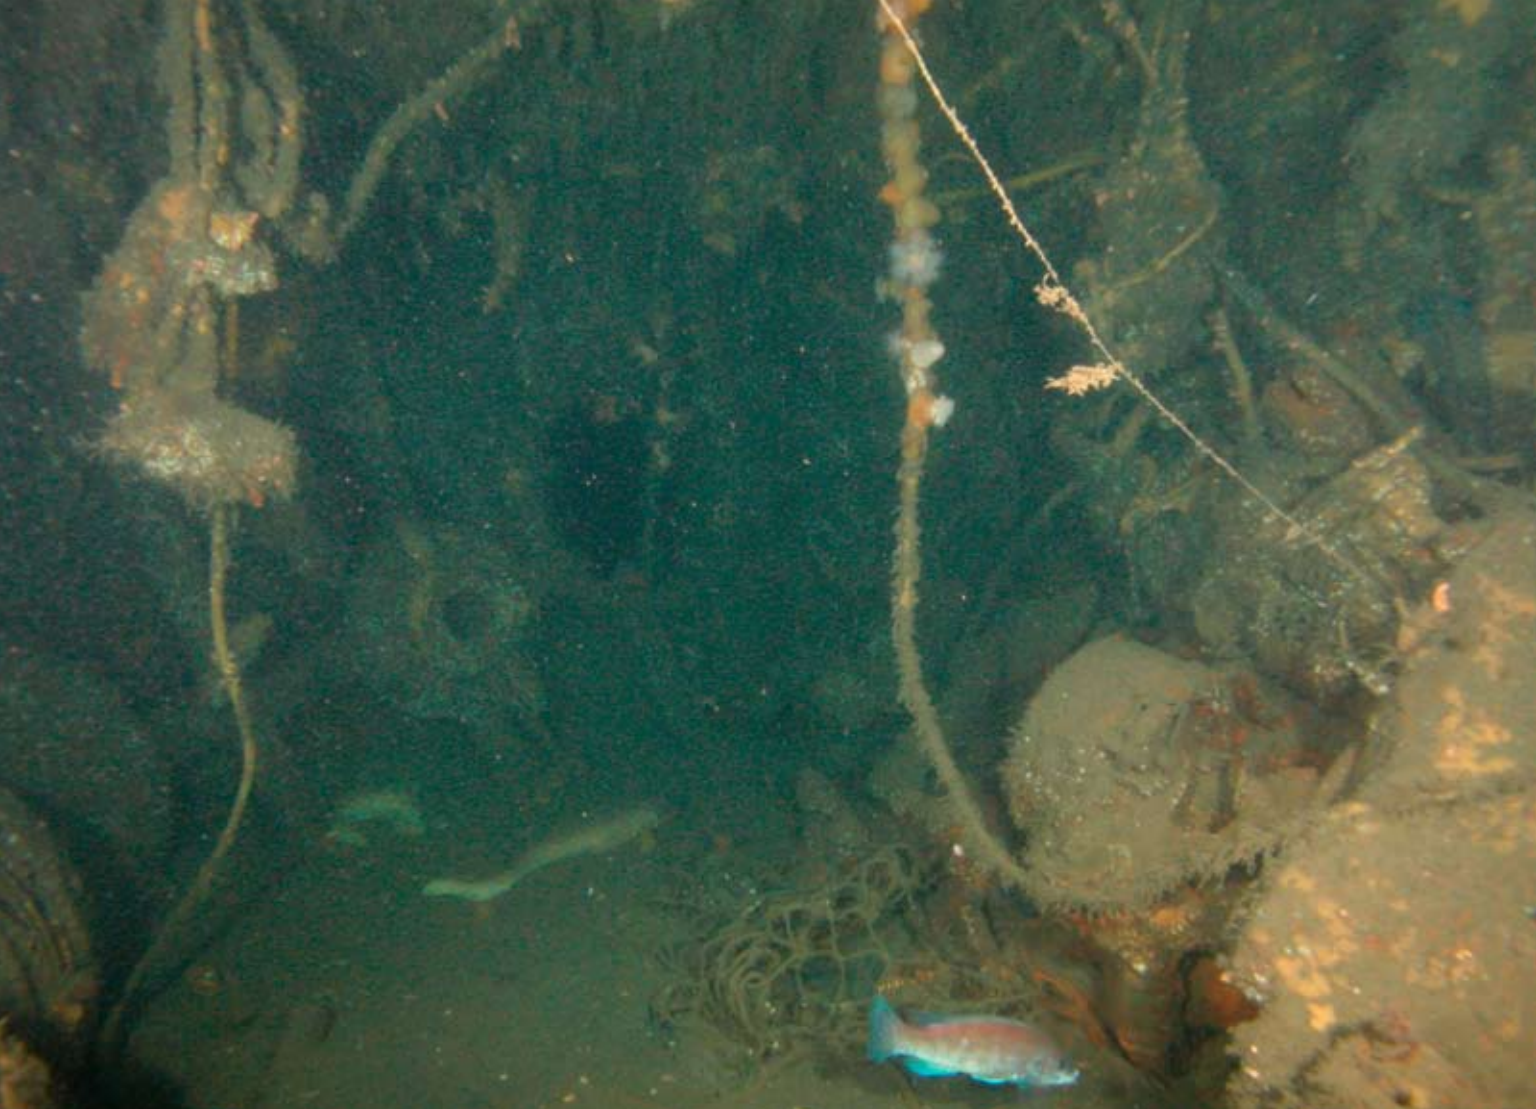
Above: Interior view of the conning tower.

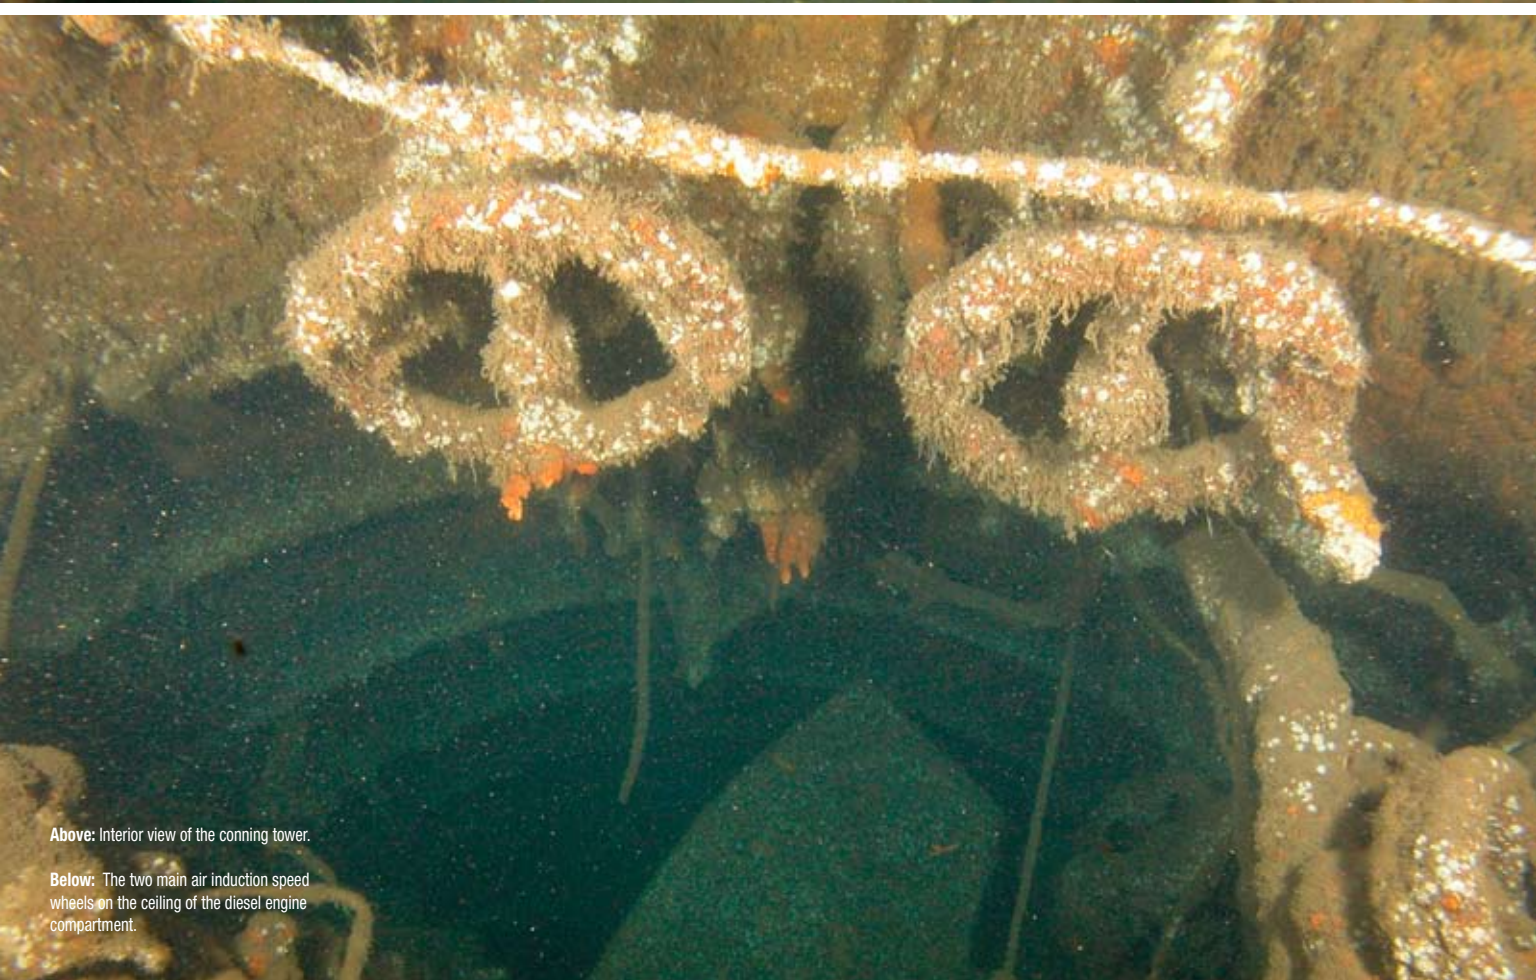
Below: The two main air induction speed wheels on the ceiling of the diesel engine compartment.
